City of Aurora

September 2013 Flood, Initial Report

Executive Summary

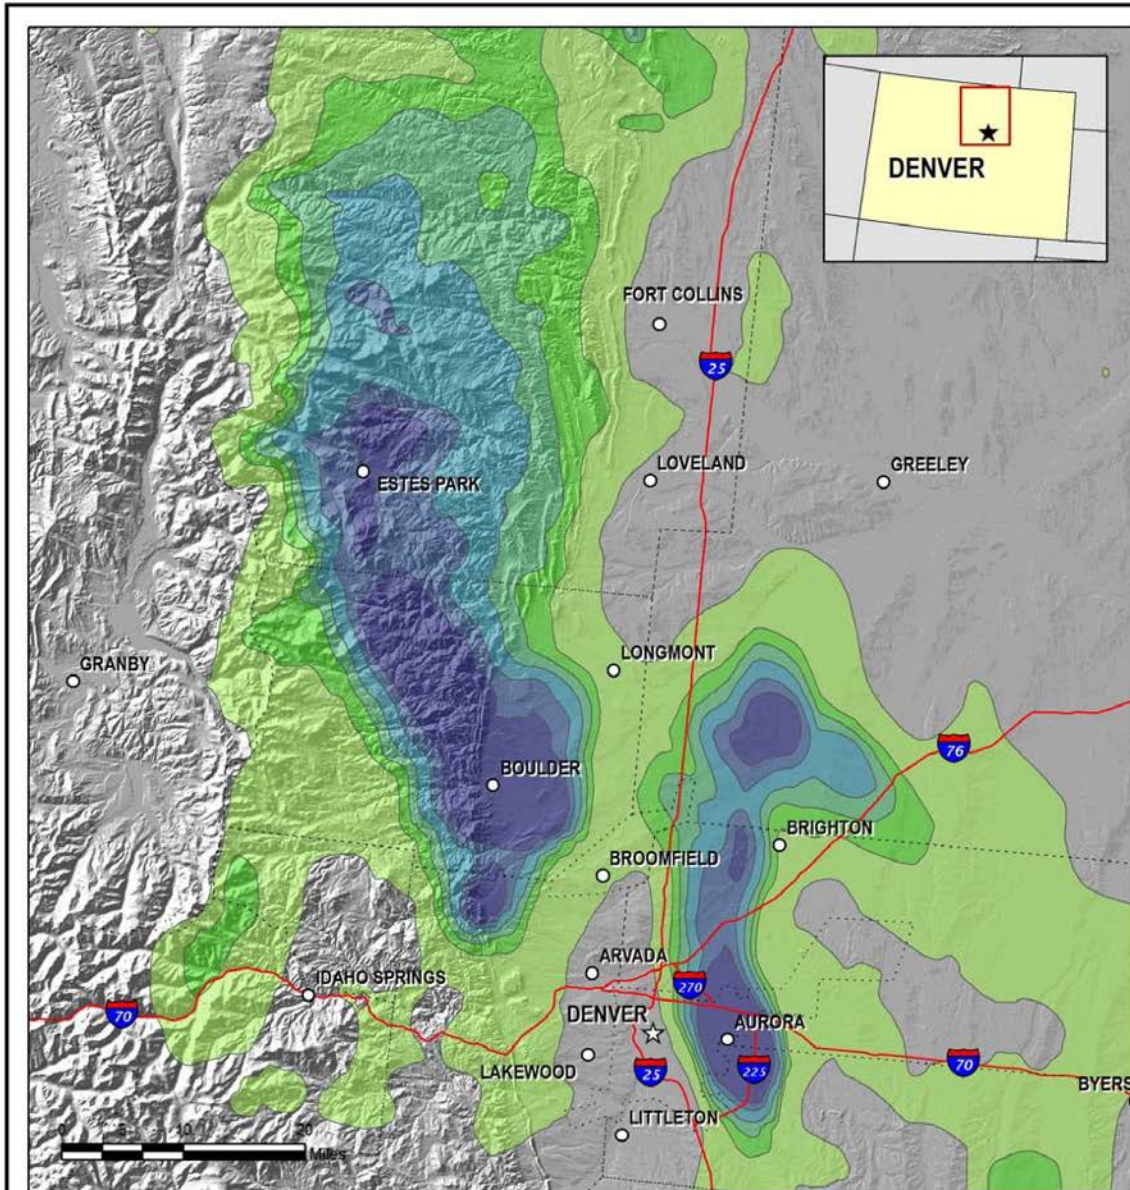
Colorado Flood Event, 9-16 September 2013 Annual Exceedance Probabilities (AEPs) for Worst Case 48-hour Rainfall

Created 17 September 2013
Precipitation frequency estimates are from NOAA Atlas 14, Volume 8, Version 2.
Rainfall values come from 6-hour multi-sensor data.

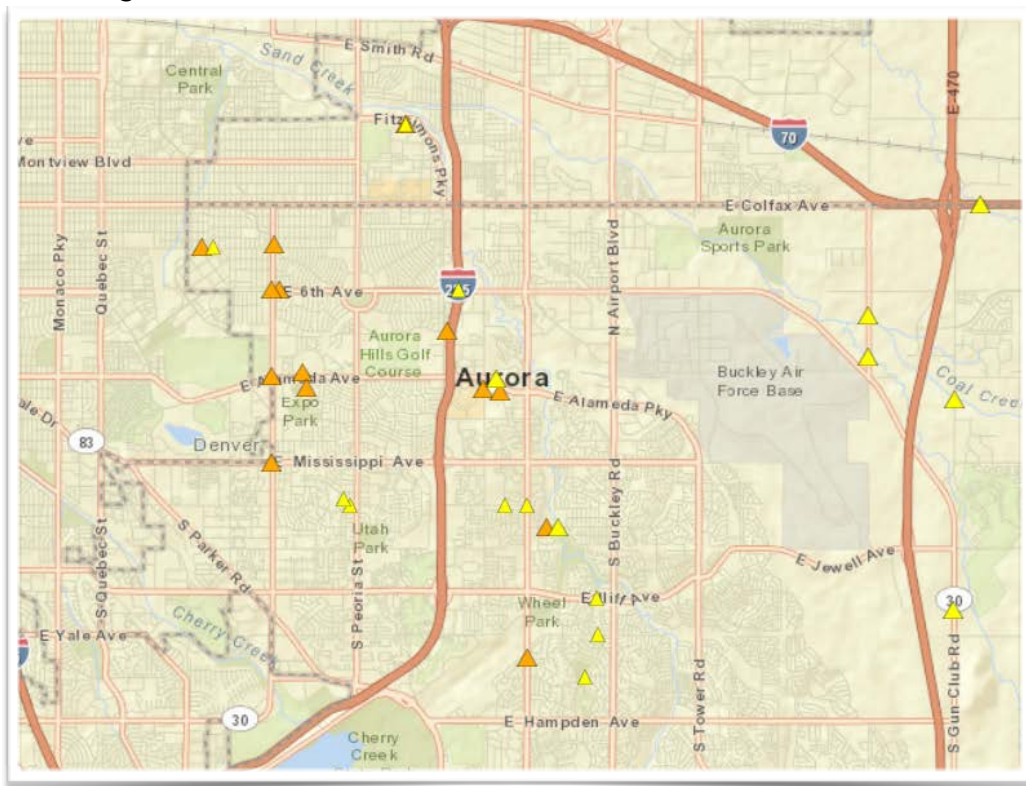
Flood damaged points within the city

This 1,000 year storm caused damage to the Aurora Water system. Some of the more notable damage areas are listed below.

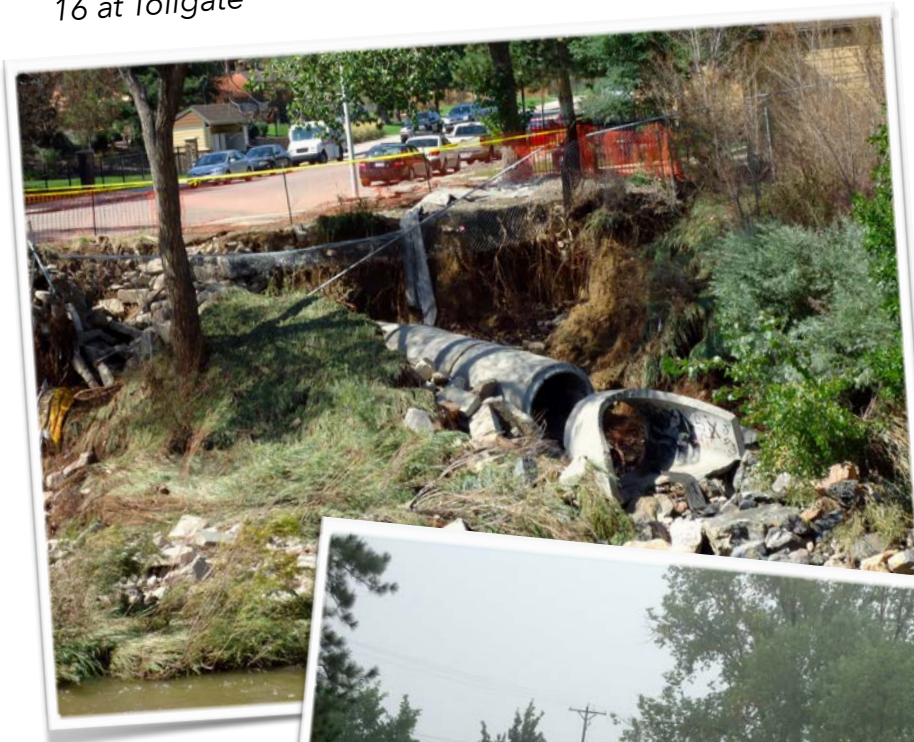
16 at Tollgate

Tollgate Creek near 17th Avenue presented some of the more extensive after the fact damage. Initial estimates for repair in Adams County for Aurora Water Control Facilities are: \$566,529

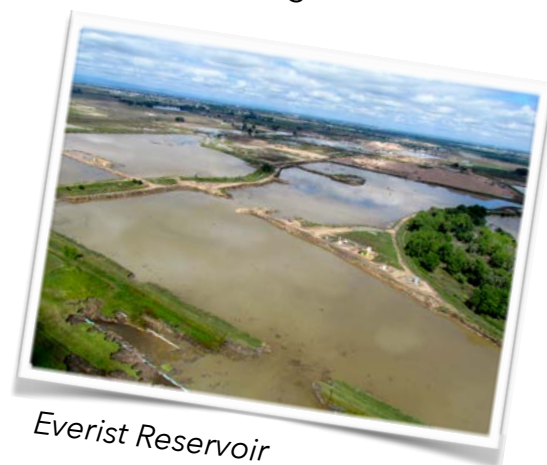
Everist Reservoir

Weld County experienced some of the heaviest damage for Aurora Water—the primary culprit coming from the failure at Everist Reservoir.

Jonathan Villines notes: “we had a couple of levee breaches there which can be seen pretty clearly in the pictures. We have a designer and a contractor on board for repairs, and once the design is finished we will start work on reconstruction (probably January 2014).

The repair cost for Weld County for Aurora Water is \$1,508,038

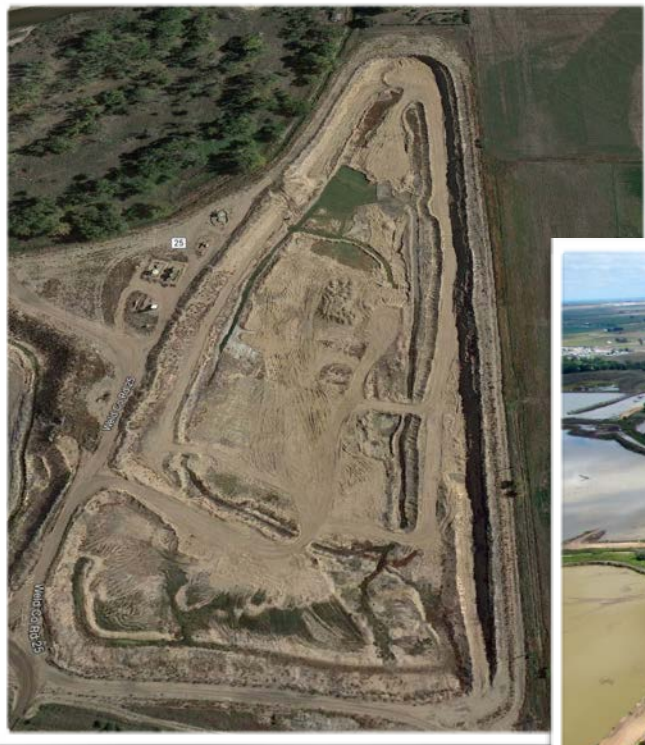
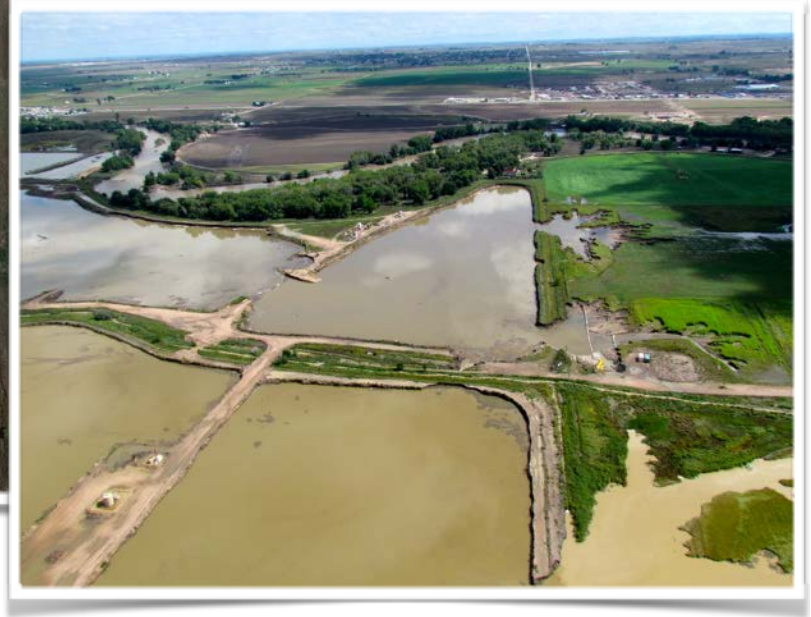
Everist Reservoir (Before)

Everist Reservoir (After)

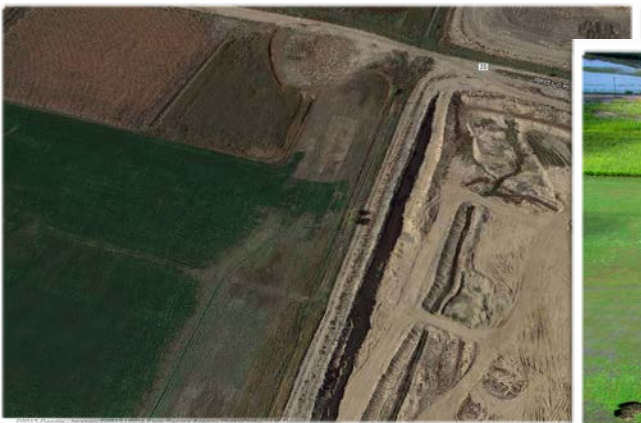
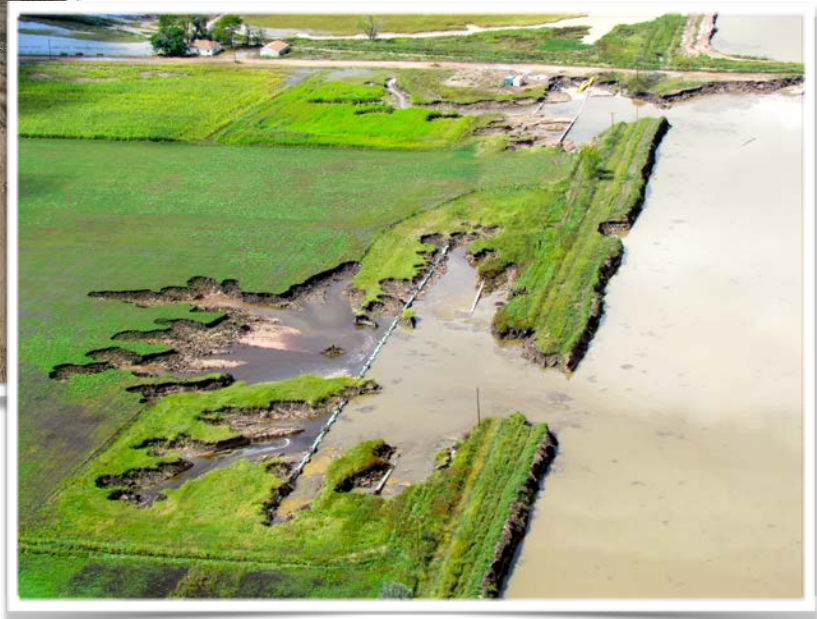
Everist Reservoir (Before)

Everist Reservoir (After)
